NCO HOUSING TYPE 2 A

BUILDINGS 5302, 5303, 5304, 5306, 5307, 5308,
5311, 5312, 5314, 5315, 5317, 5318

CONDITION SURVEY

FIVE UNIT ROW HOUSES

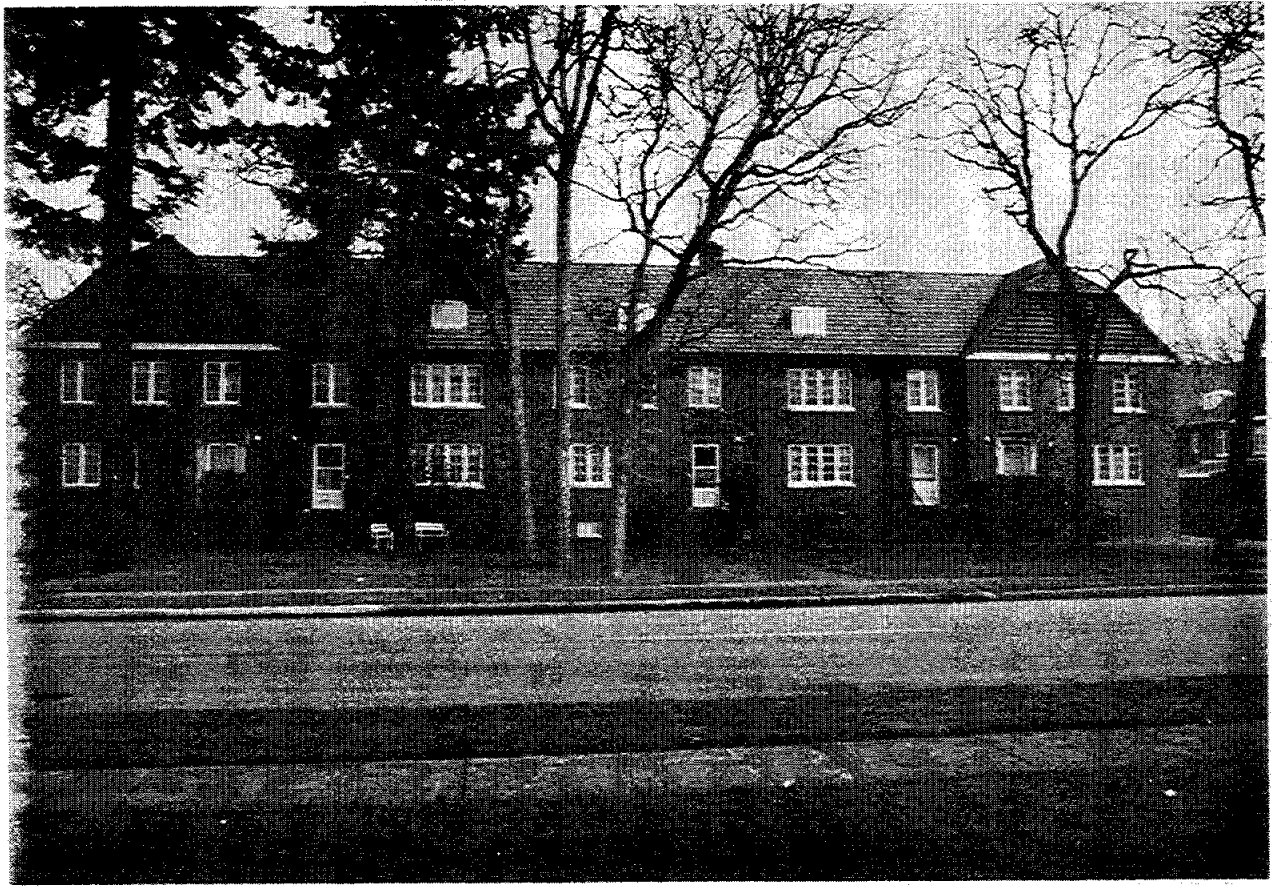
1987 PHOTO

The five unit row houses were constructed in 1940 from standard quartermaster general plans. Except for the addition of rear decks and storage sheds, and the removal of most original porch lights and downspout leader heads, the buildings are close to original design.

The row houses are constructed of brick on concrete foundations. Windows are steel sash, sills and entry portals are stone. The wrought iron railings will need attention shortly due to rust formation at posts.
